A HISTORIC STRUCTURES REPORT ON THE ERIE-LACKAWANNA TERMINAL AT HOBOKEN, N.J.

prepared by the Hoboken Community Development Agency May, 1982
 written & researched by Patricia Florio, Restoration Specialist

ERIE LACKAWANNA TERMINAL
HISTORIC STRUCTURES REPORT
HOBOKEN, N.J.

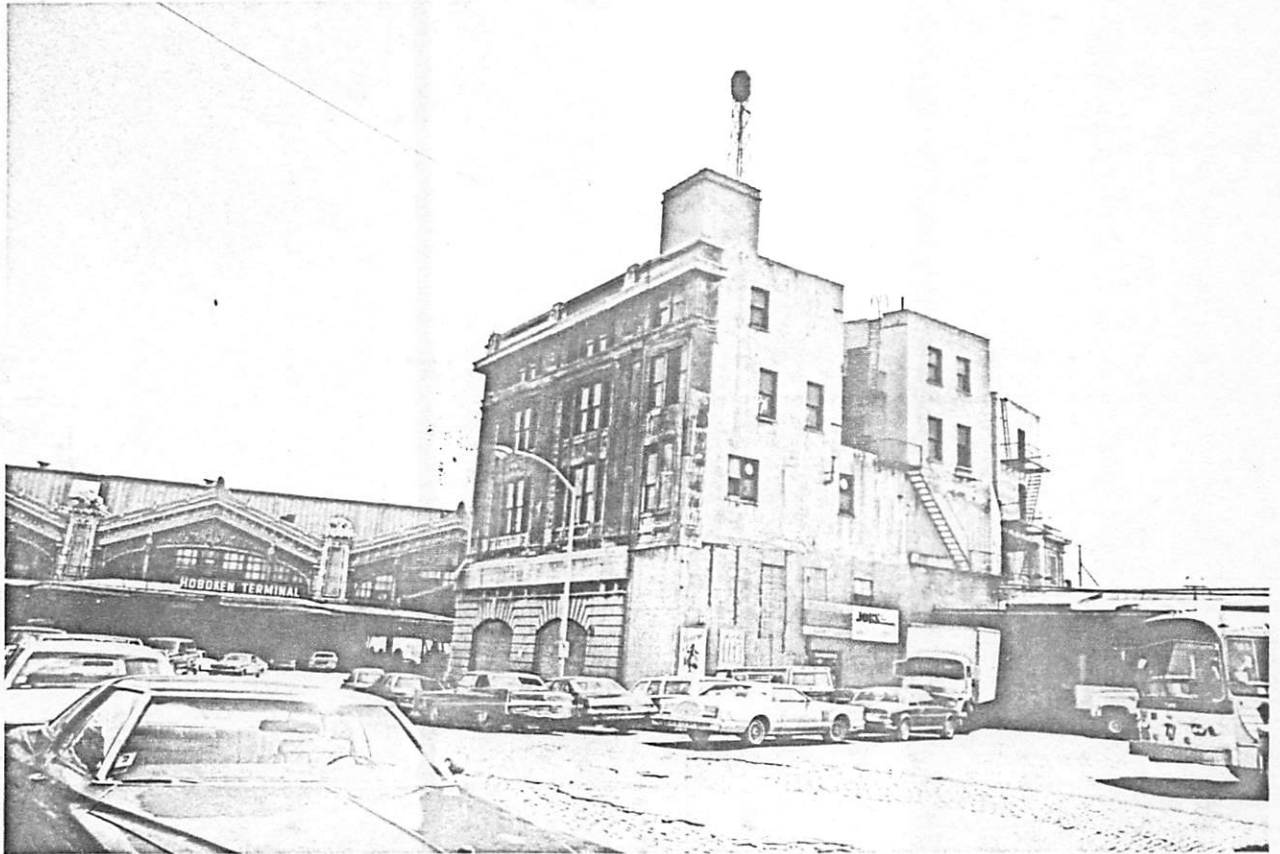
Western facade of terminal, viewed from roof of train concourse.
Note large gap in section of copper cornice above arch.

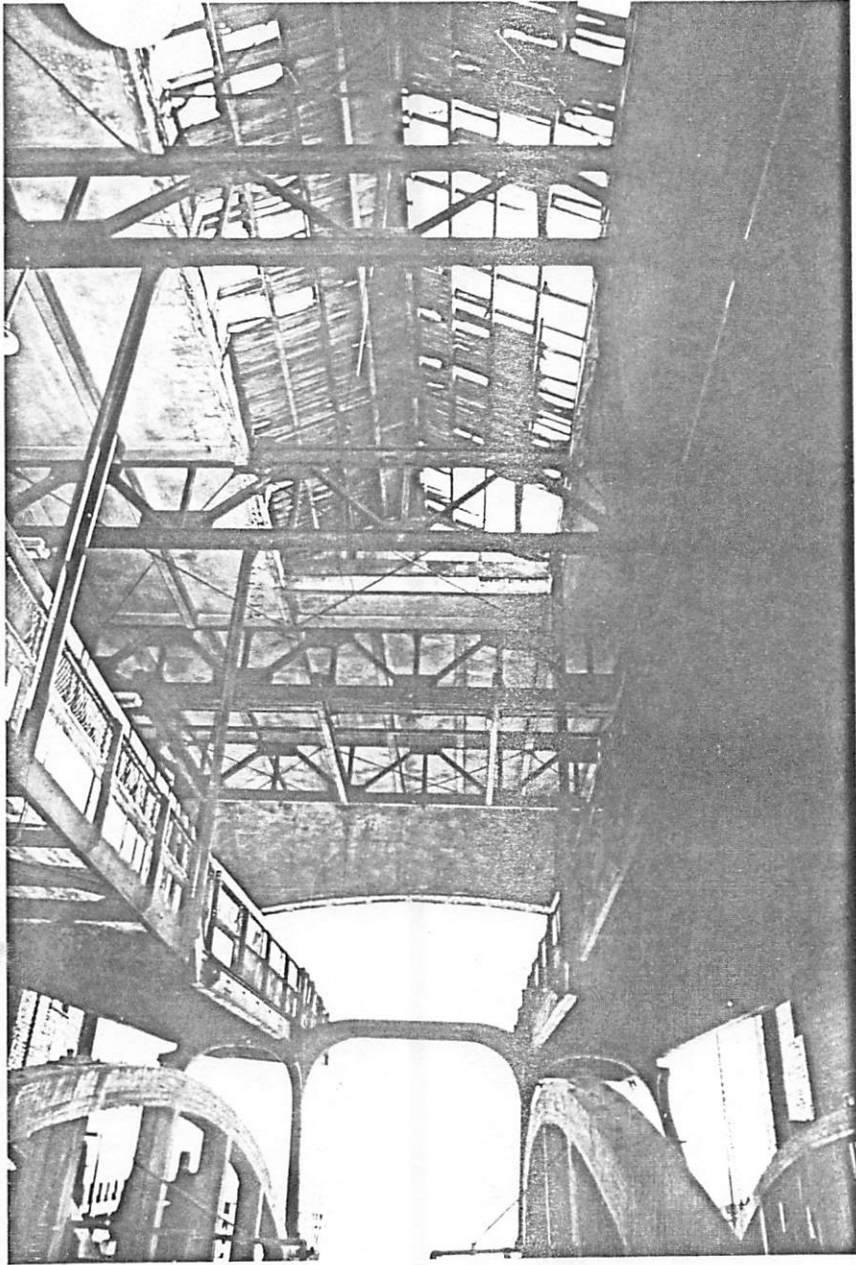
Skylight over Slip B.

1. Ferry Building, and southern facade of main waiting room building, should undergo continued copper restoration. Glazed skylights over ferry landing areas should be re-glazed to protect structure.
2. Ferry slips, and Slip No. 1. These areas should be objectively surveyed to access their condition and function as shields to the terminal, as well as integral parts of the overall design of the complex.
3. The Immigrant/Pullman Building should be retained, given its special historical significance.
4. Future development should include the replication of the original lighting scheme on the facade's perimeter.
5. Cobblestones of Ferry Plaza and Hudson Place should be retained when area is regraded.

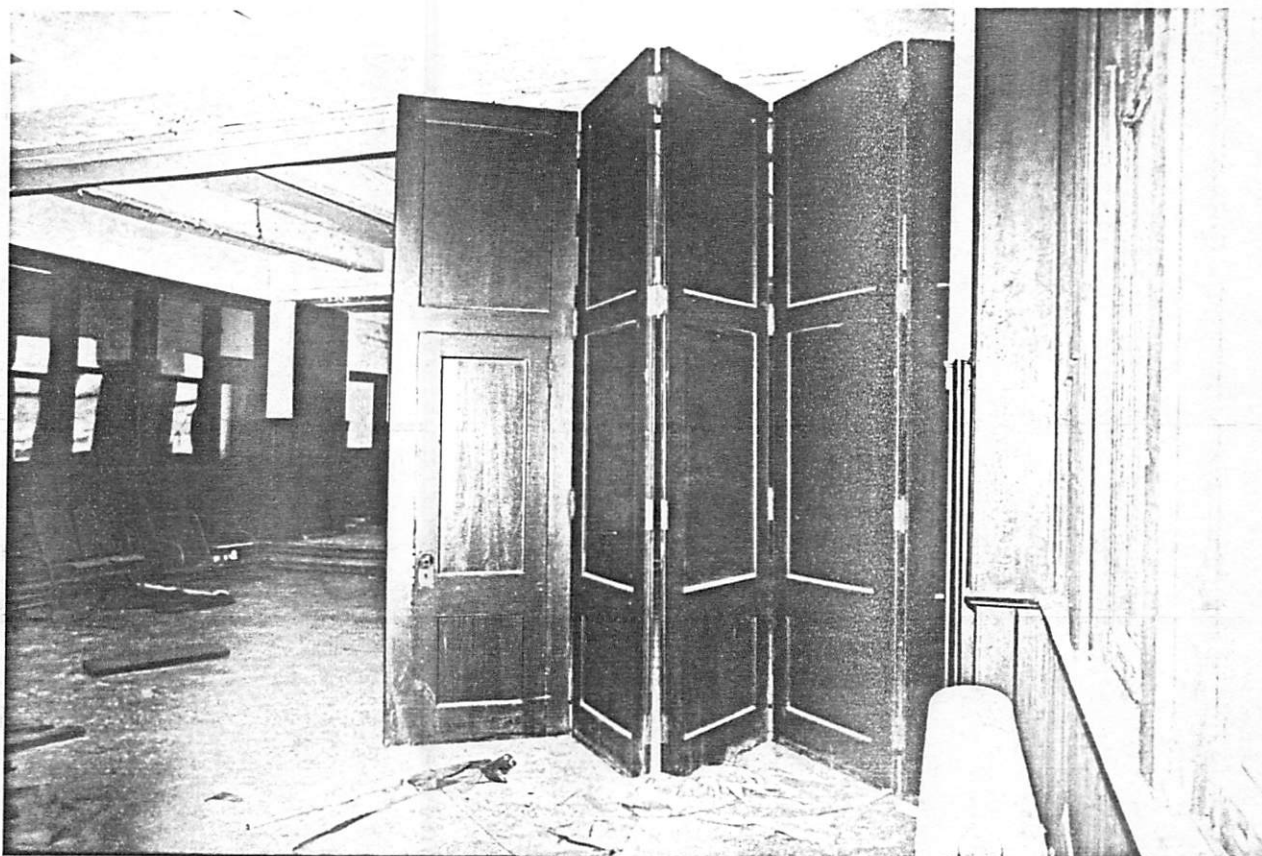
Second story auditorium/lunchroom at eastern end of YMCA Building, stage area.

Wooden sliding doors are intact in the stepped second floor of the YMCA Building auditorium/lunchroom.

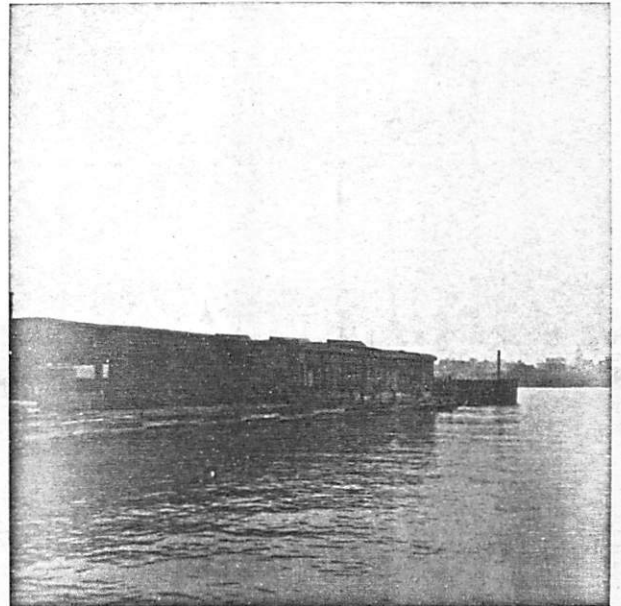
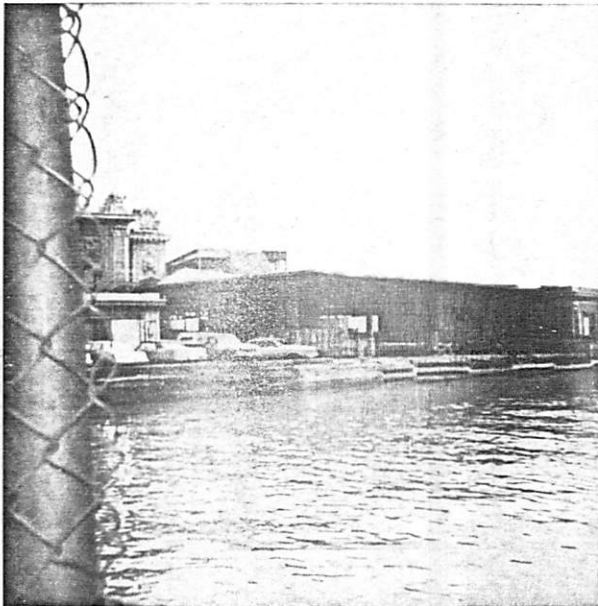
Southern facade of terminal: to left, overall view; to right, projecting police office building, with facade of former restaurant visible above.

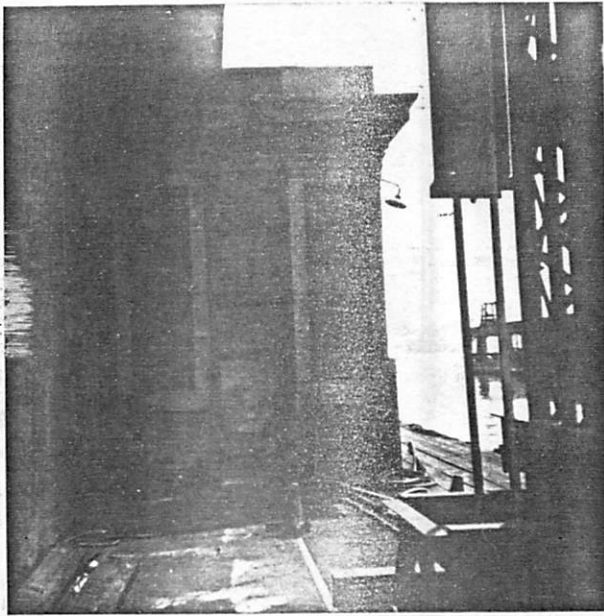
Slip No. 1: to left, shed-roof over slip; to right, classically-detailed dock building which is contemporary with terminal.

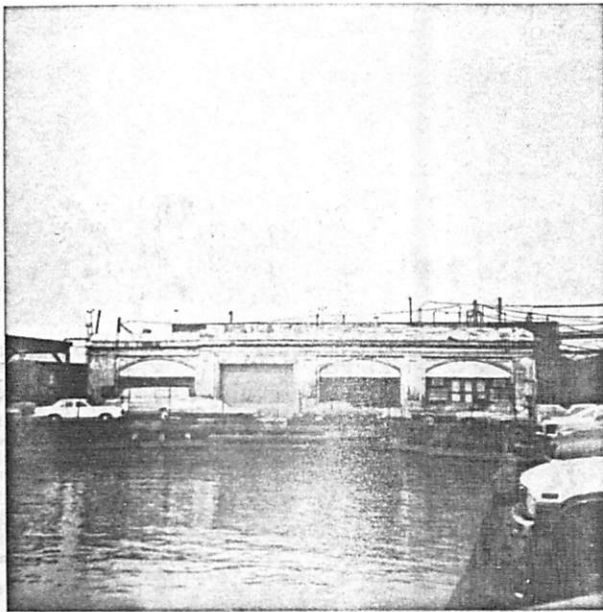
Detail of southern end of dock building on Slip No. 1,

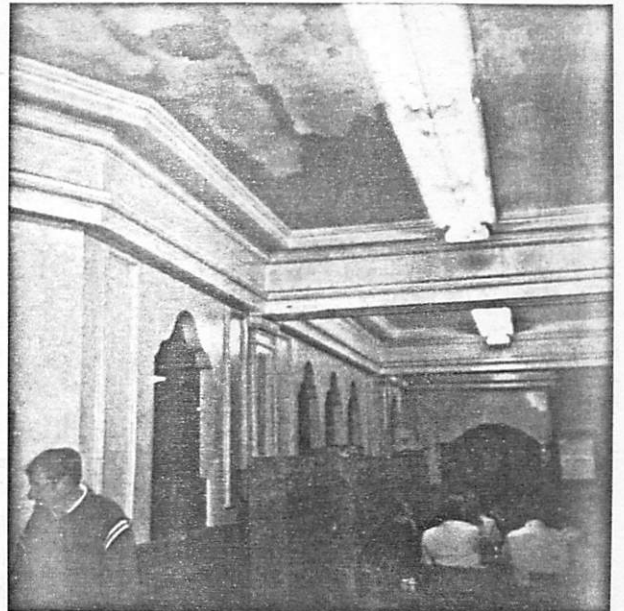
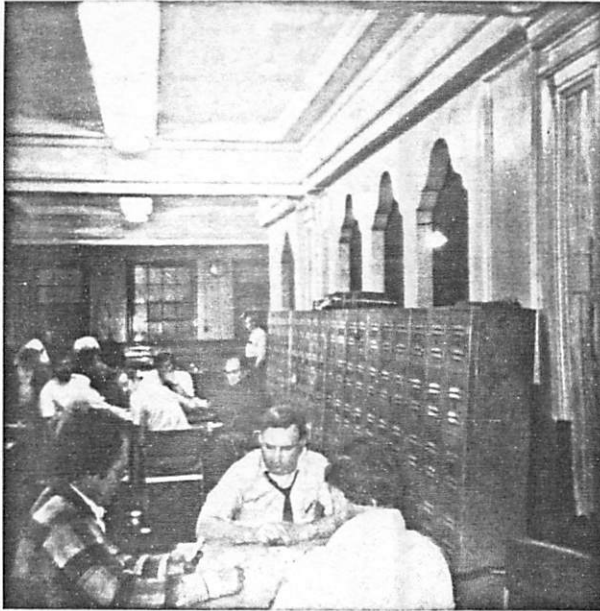
Views of the Immigrant and Pullman Building on Slip No. 1

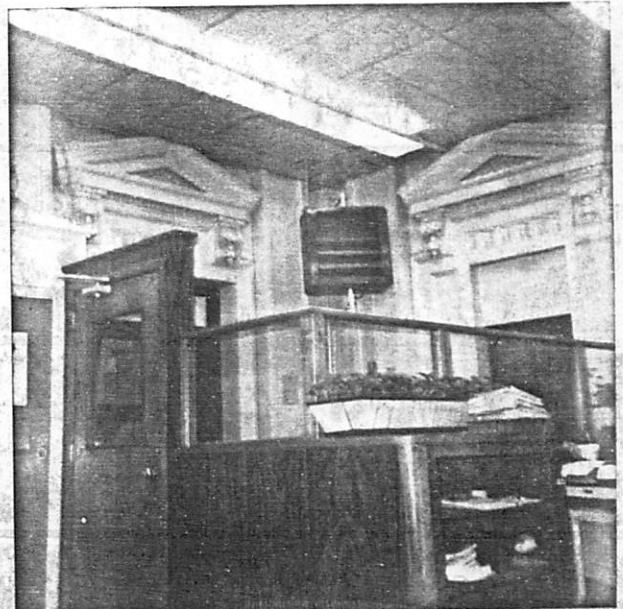
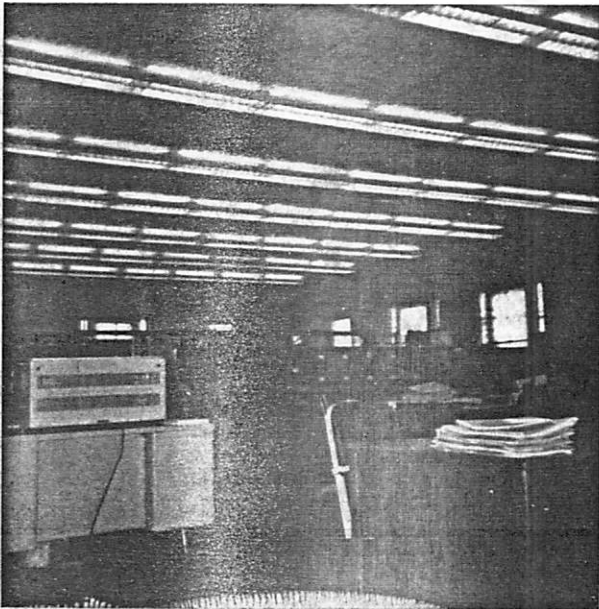
Second storey former restaurant, to left, view of wall facing south; to right, view of roof garden, once covered by an awning, with views toward the New York skyline.

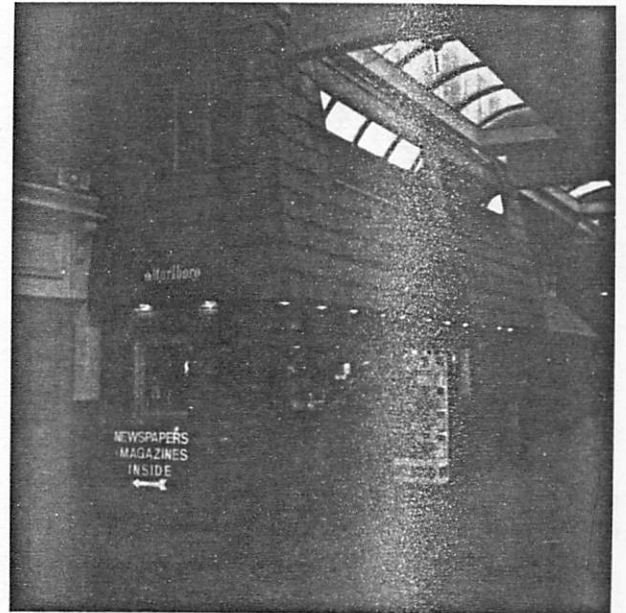
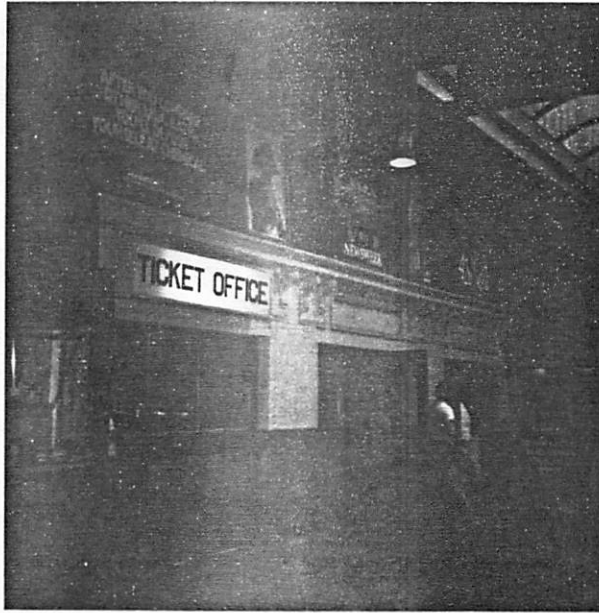
Interior of second story restaurant; a hung ceiling obscures an oval, plaster vaulted ceiling. This room is now used for administrative Conrail offices.

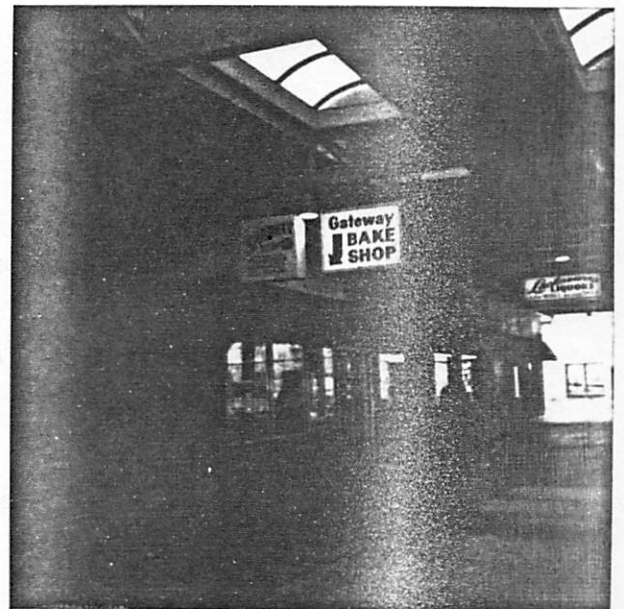
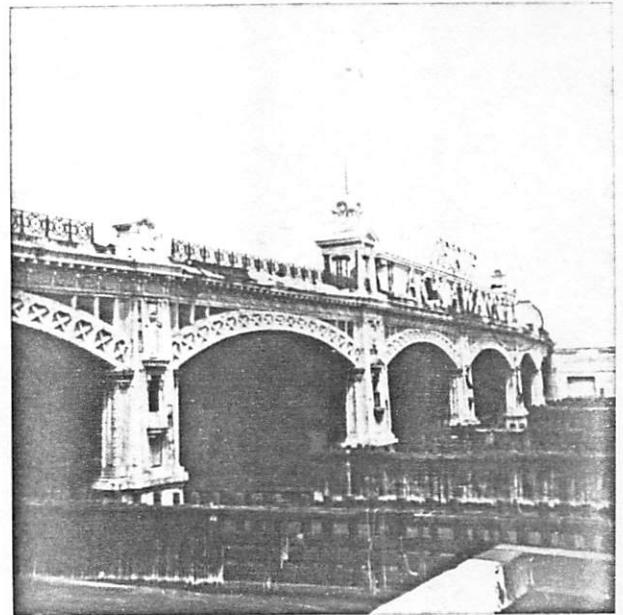
Train concourse, views running from north to south.
Bracketted vestibules are oriauthentic features of the terminal.

Riverfront copper facade of terminal, as viewed from Slip. No. 1. Segments of missing copper reveal steel structure beneath. Ferry "bumpers" and pilings are evident in view to lower right.

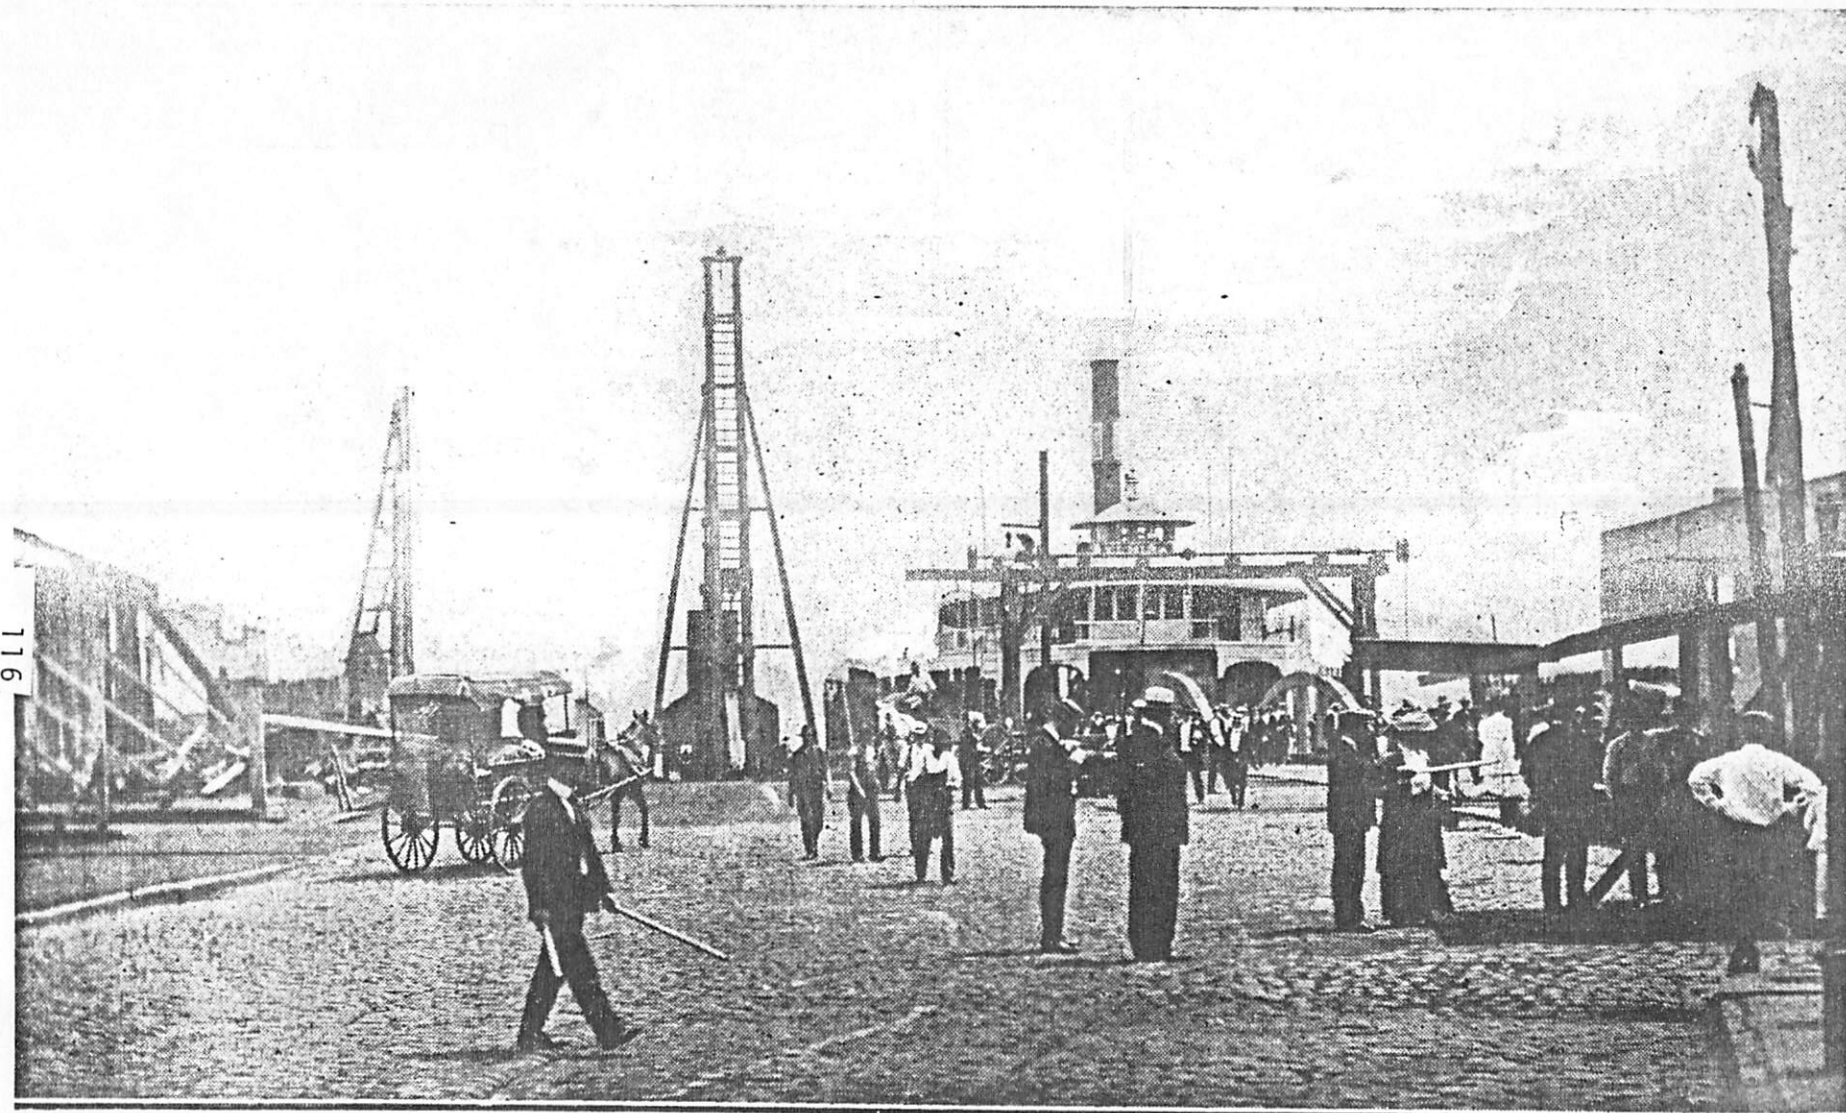
Trollies circle near site of Aug. 5, 1905 fire which destroyed Hoboken terminal, and cleared the way for the present terminal. (Photo by W.J. Barry, collection of Syracuse University, courtesy of John Willever)

ENTRANCE TO HOBOKEN FERRY AFTER FIRE, 8-7-'05.

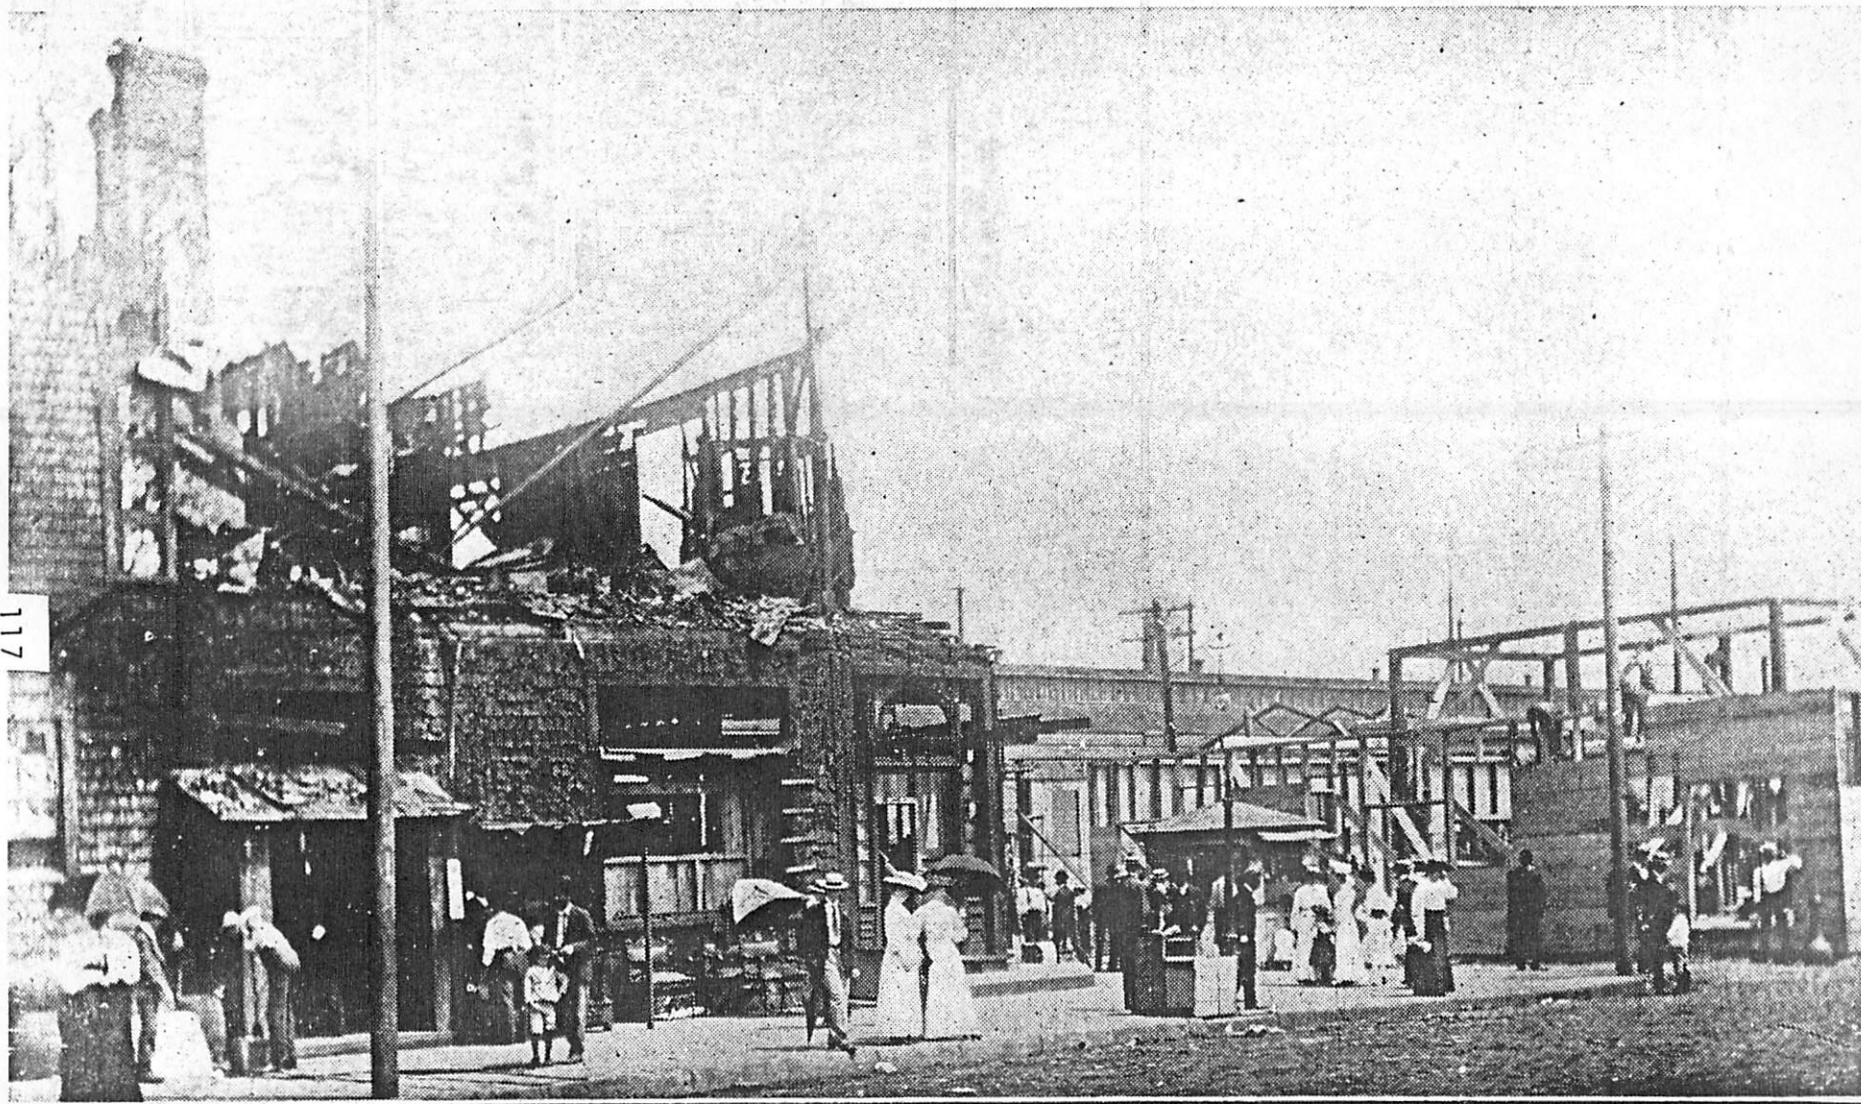
The ferryboat Elmira (built in 1905) in slip at the site of the Hoboken Terminal. Some of the apparatus of the slips of the former terminal--the rolling logs and ramps--are thought to have been reused in the 1907 building. Postcard view, courtesy, Hudson City Historical Society, Theodore Conrad Collection.

RUINS OF HOBOKEN FERRY FIRE 8-7-'05.

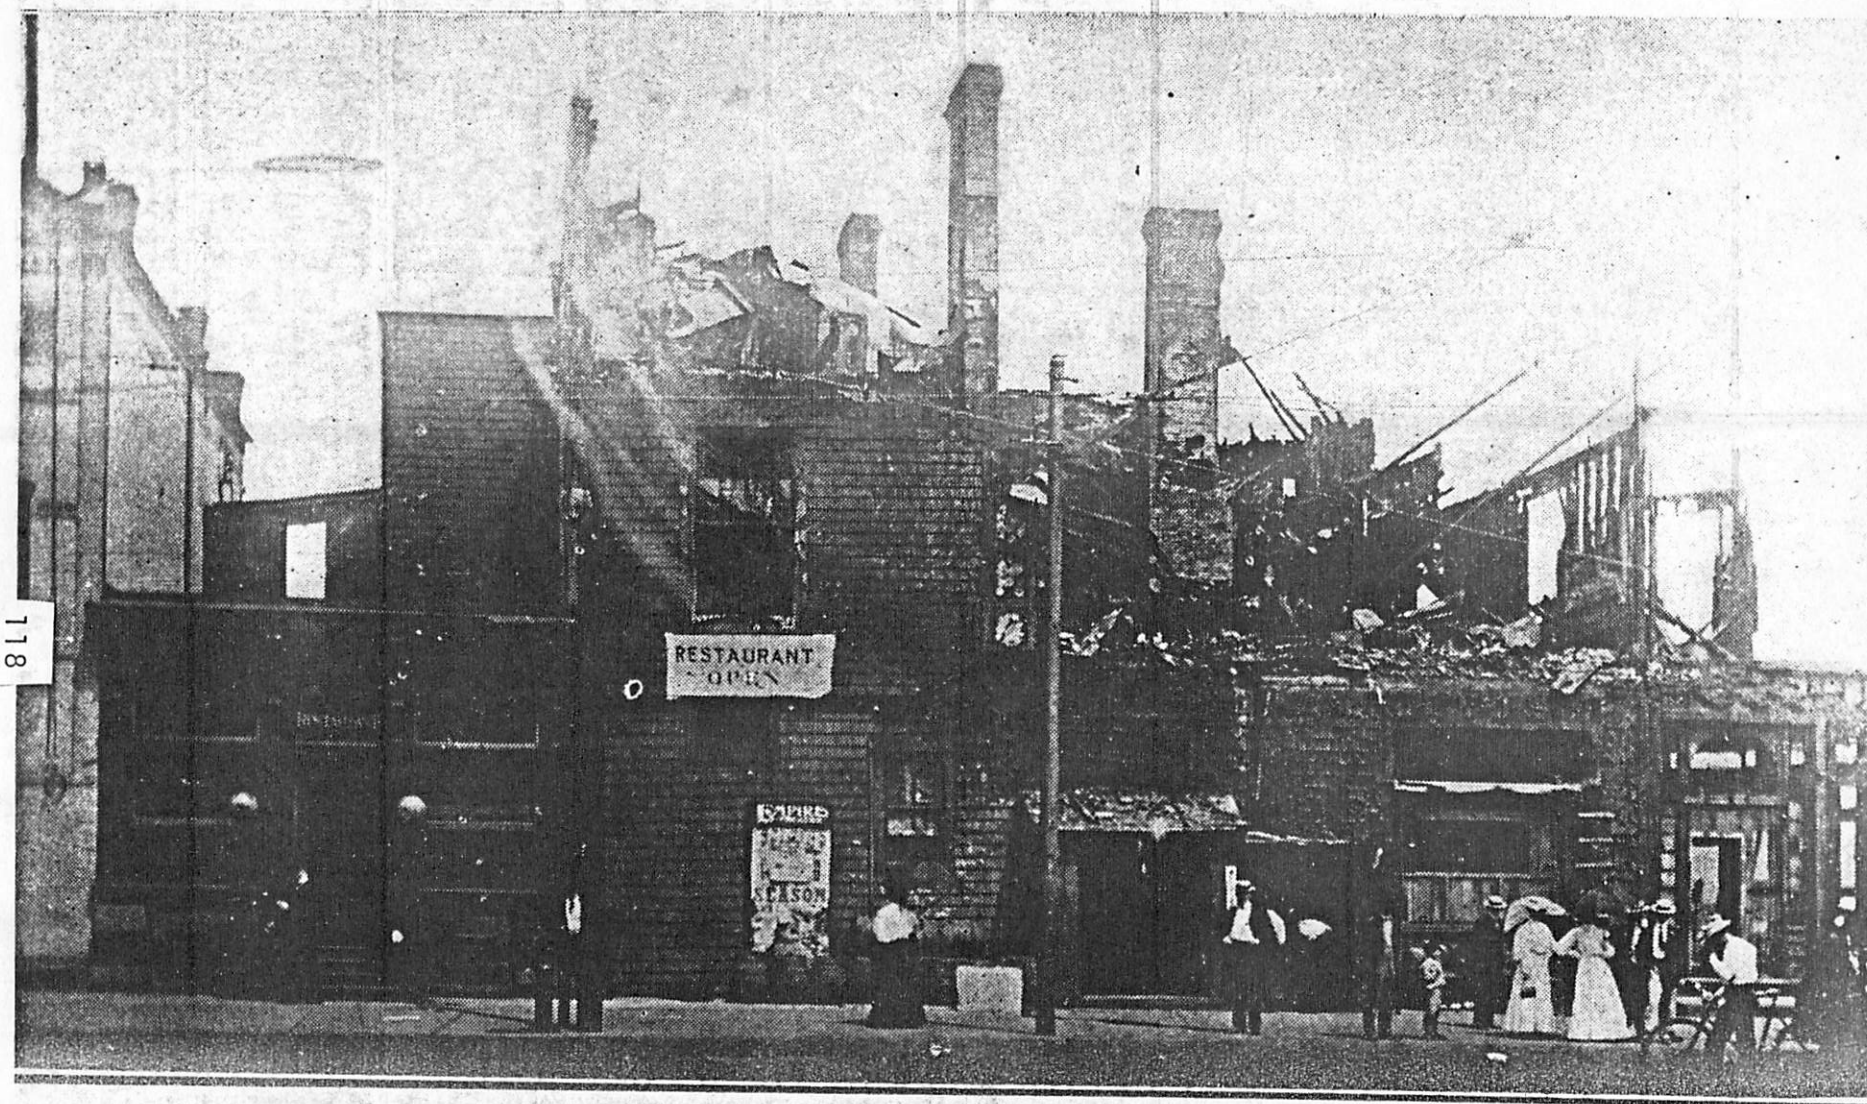
Temporary shelter for ferry company being constructed on ferry plaza immediately after the fire of August, 1905. Enlarged post-card view, courtesy Hudson City Historical Society, Theodore Conrad Collection.

DUKE'S HOUSE AFTER HOBOKEN FERRY FIRE 8-7-'05.

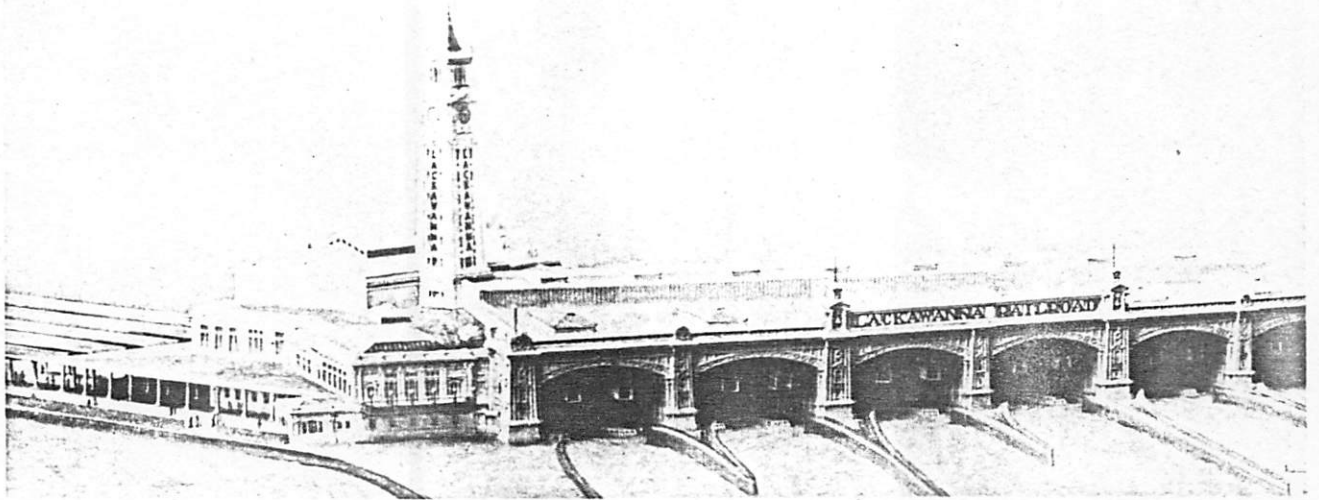
Enlarged postcard view of the restaurant Duke's House on Hudson Place, in ruins after the fire that destroyed the stick style terminal. Courtesy, Hudson City Historical Society, Theodore Conrad Collection.
